# **Total Maximum Daily Load: Little Willow Creek Richland County, WI**

**Little Willow Creek, Richland County, WI  
Report Prepared by Mike Gilbertson**

**Sediment Total Maximum Daily Load for Little Willow Creek**

## Little Willow Creek Sediment TMDL, Final July 30, 2008

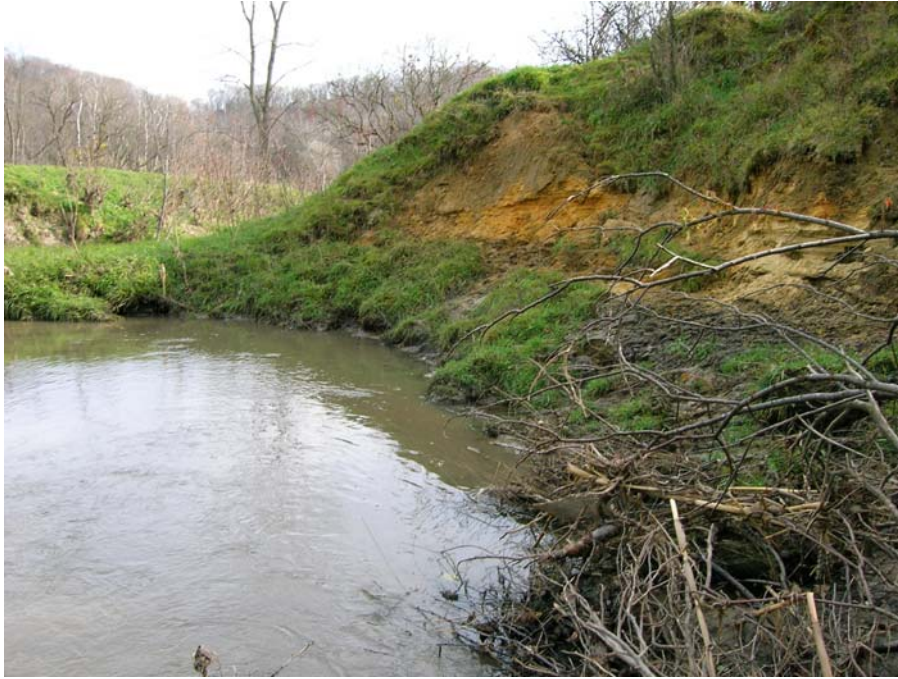
**Figure E-1.** Typical bank erosion along Little Willow Creek downstream of Spiral Road

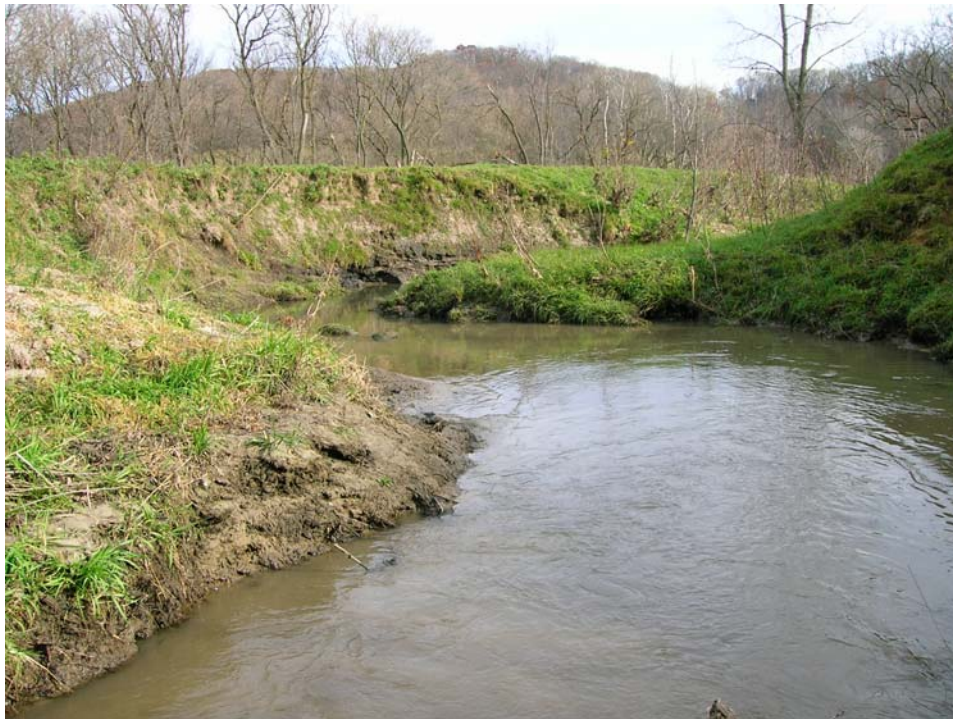
**Figure E-2.** Typical bank erosion along Little Willow Creek downstream of Spiral Road

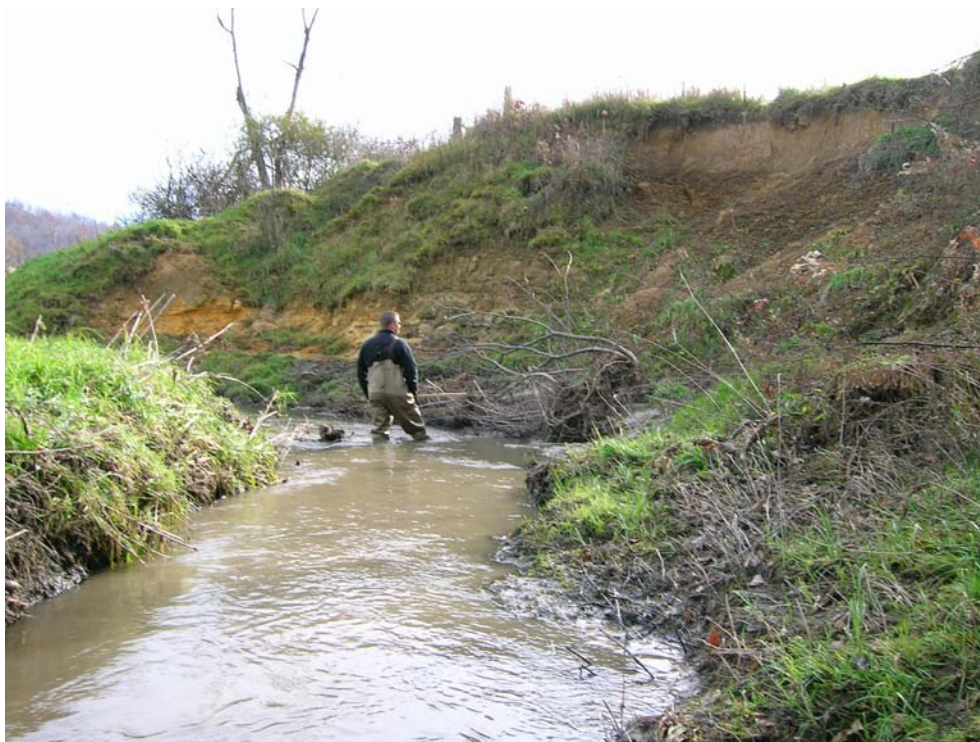
**Figure E-3.** Typical bank erosion along Little Willow Creek downstream of Spiral Road

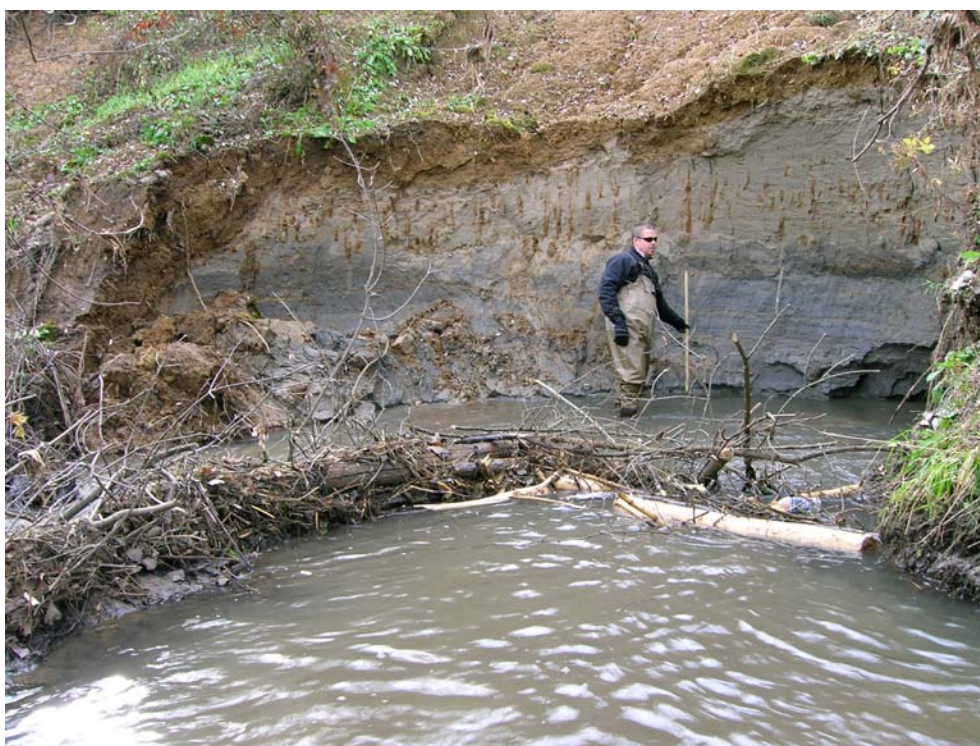
**Figure E-4.** A section of the stream bank was carved out as a result of the August 2007 flooding.

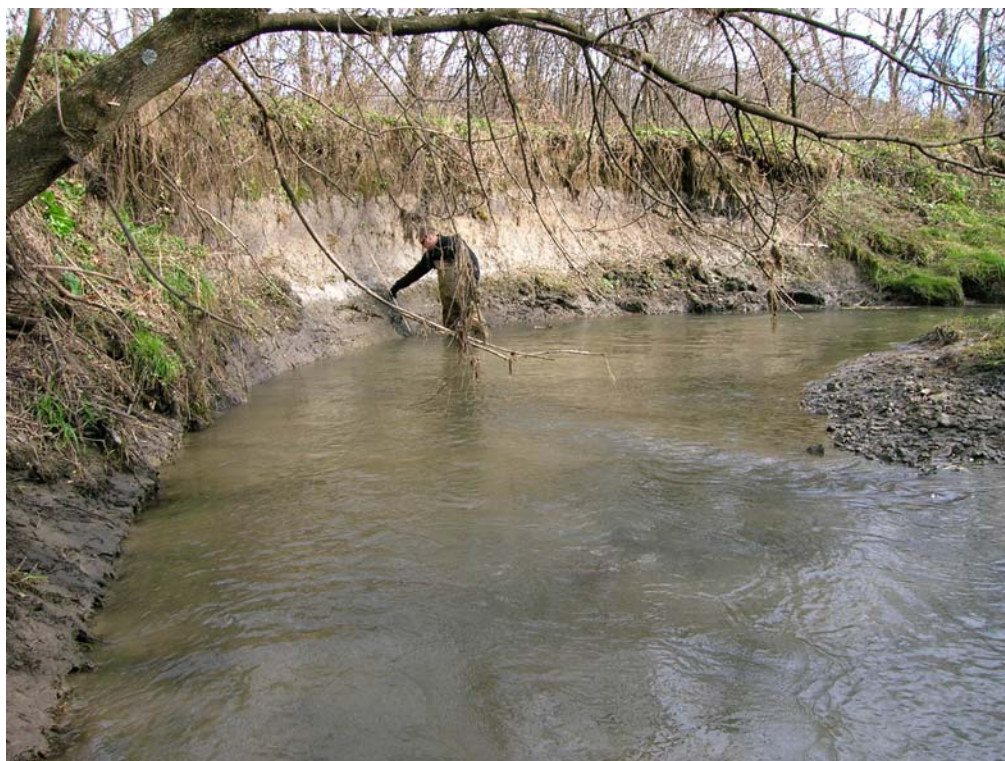
**Figure E-7.** Typical bank erosion along Little Willow Creek downstream of Spiral Road
