# **Total Maximum Daily Load: Little Willow Creek Richland County, WI**

**Little Willow Creek, Richland County, WI  
Report Prepared by Mike Gilbertson**

**Sediment Total Maximum Daily Load for Little Willow Creek**

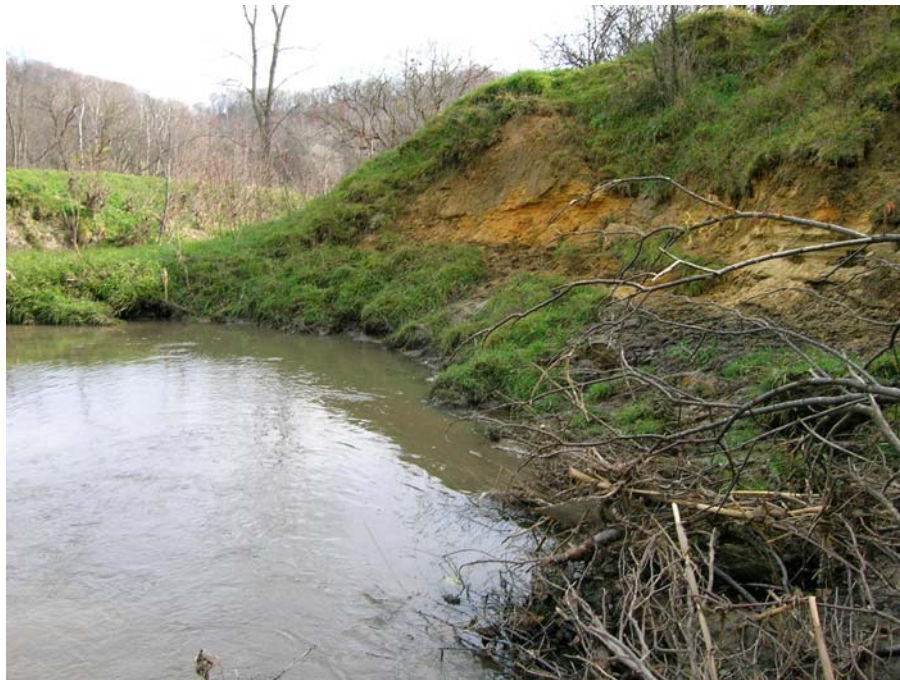
**Figure E-1.** Typical bank erosion along Little Willow Creek downstream of Spiral Road

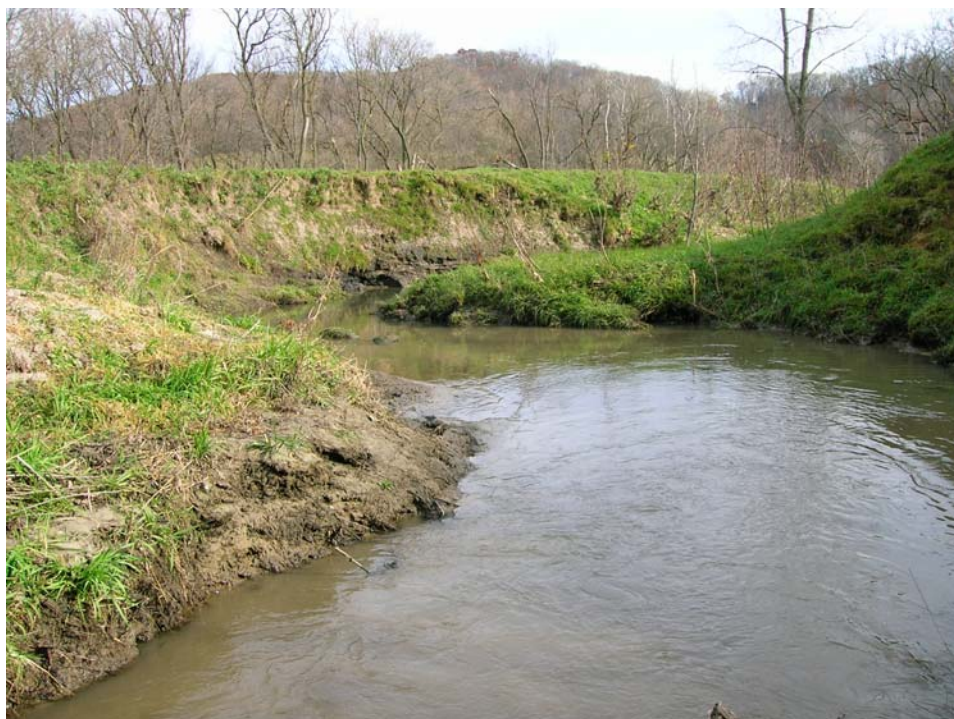
**Figure E-2.** Typical bank erosion along Little Willow Creek downstream of Spiral Road

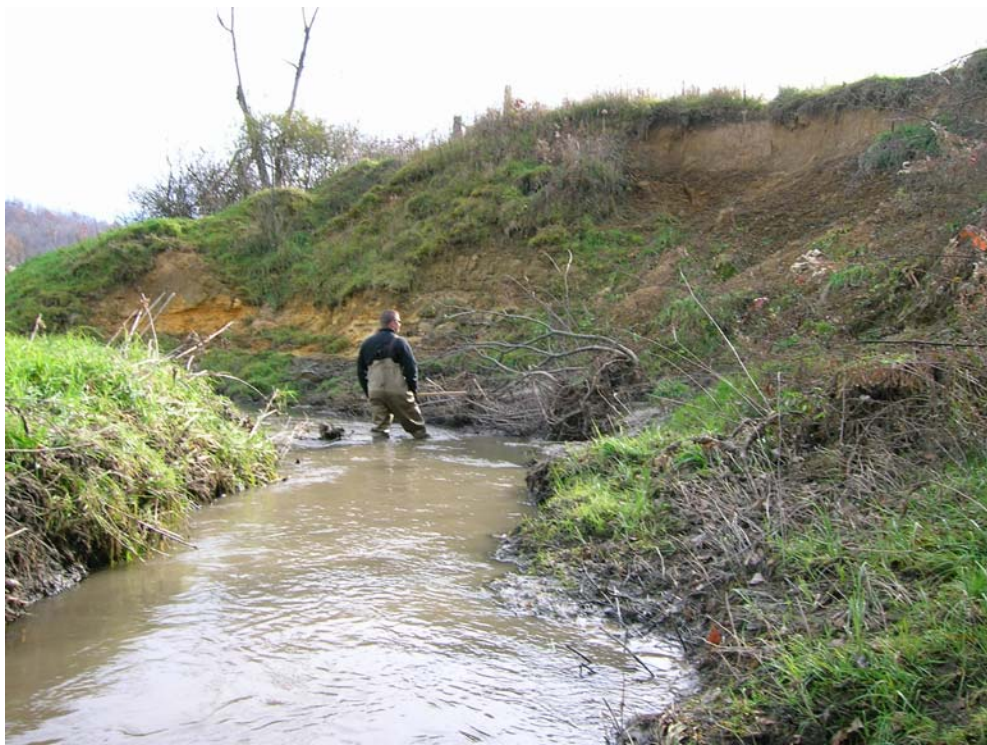
**Figure E-3.** Typical bank erosion along Little Willow Creek downstream of Spiral Road

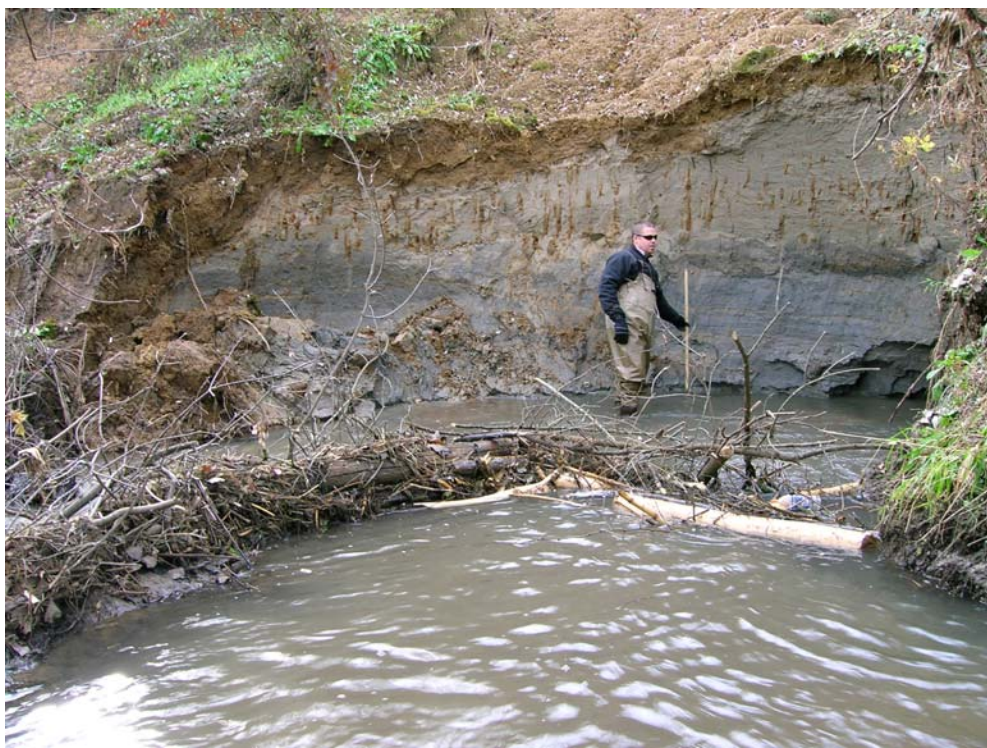
**Figure E-4.** A section of the stream bank was carved out as a result of the August 2007 flooding.

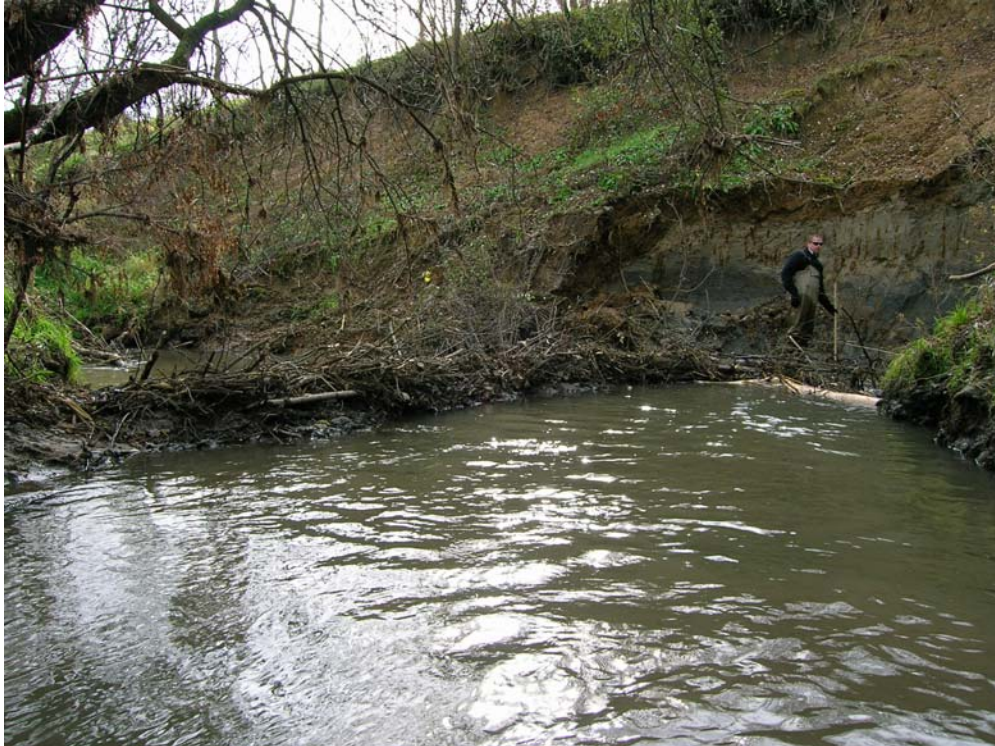
**Figure E-5.** A section of the stream bank was carved out as a result of the August 2007 flooding.

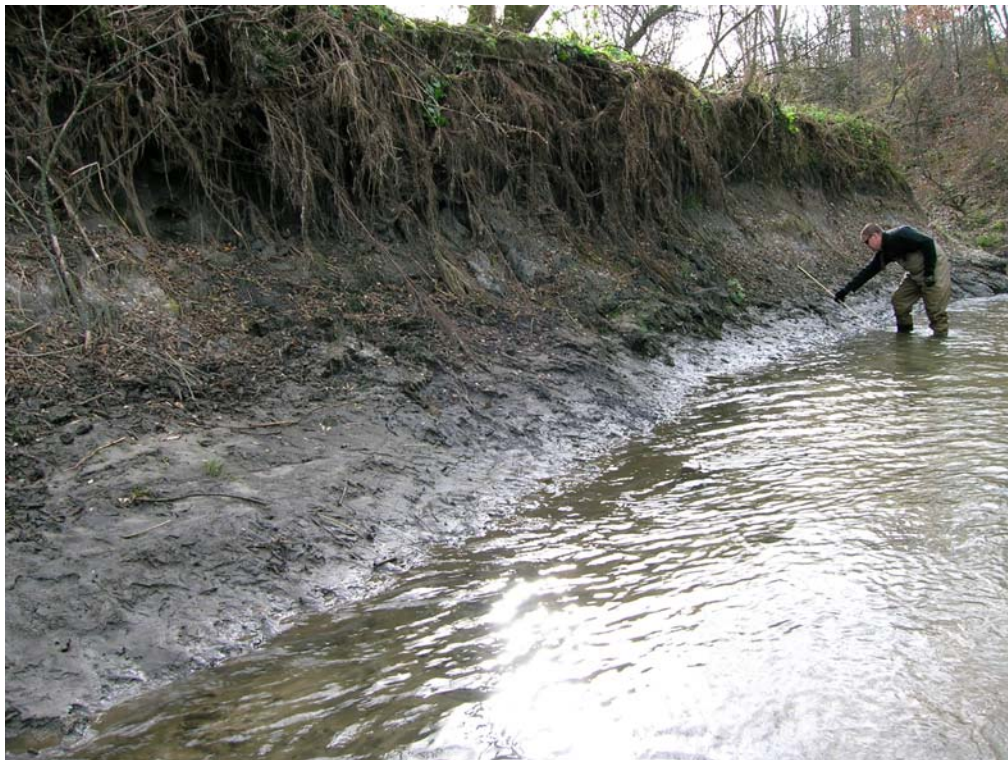
**Figure E-6.** Typical bank erosion along Little Willow Creek downstream of Spiral Road

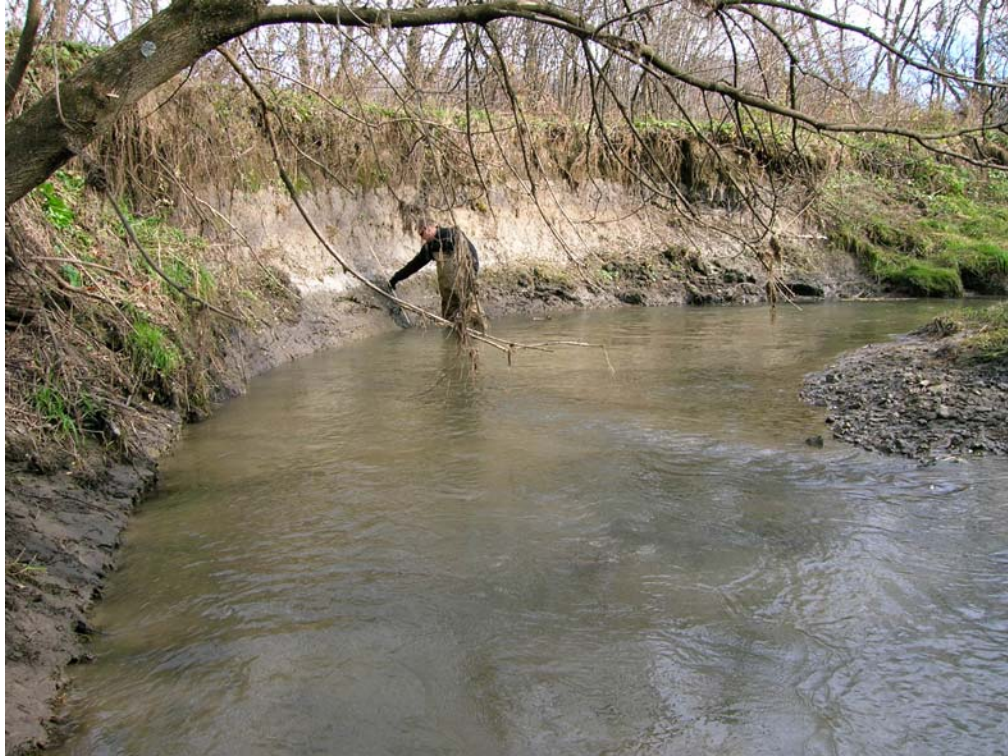
**Figure E-7.** Typical bank erosion along Little Willow Creek downstream of Spiral Road
